2019 TAILINGS SUMMARY REPORT REVISION 1

# COMMITTED TO RESPONSIBLE TAILINGS MANAGEMENT

# AGNICO EAGLE'S COMMITMENT TO RESPONSIBLE TAILINGS MANAGEMENT

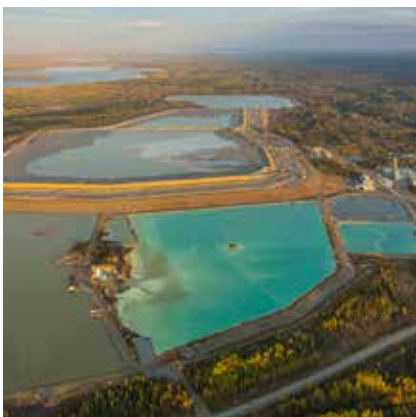
Example of slurry tailings facility  
*LaRonde mine*

Some of Agnico Eagle's sites deposit tailings as a slurry (LaRonde mine), which can release significant excess water after placement; or as thickened tailings (Canadian Malartic mine), which release only minor amounts of excess of water after placement; or as filtered tailings (Pinos Altos and Meliadine Mines), which do not release excess water after placement. See Appendix B for the definitions of the different types of tailings.

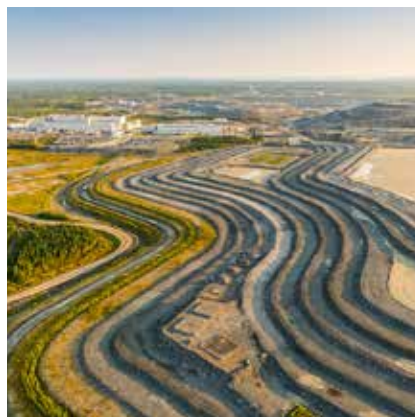
Example of thickened tailings facility  
*Canadian Malartic mine*

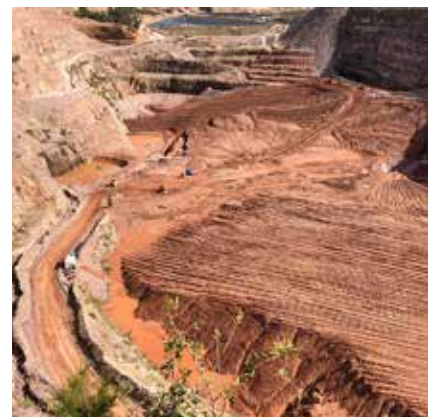
Example of filtered and compacted  
tailings deposition  
*Pinos Altos mine*

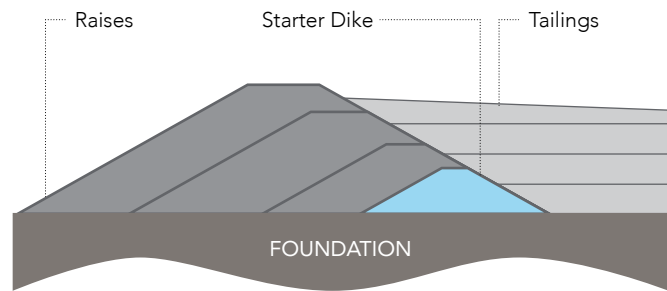
**Figure 2:** The **downstream method** involves constructing each raise on top of and downstream of the previous stage. The dike is founded entirely on natural soil. It is the costliest method and requires additional borrow material volume and space downstream. This method is generally considered as more stable because it does not depend on an additional variable: the behavior of the tailings as a foundation.

TSF are built for the management and storage of tailings. They can consist of a basin enclosed by dikes into which tailings are deposited. For practical and economic reasons, the dikes are typically raised incrementally to increase the capacity of the TSF during the life of the mine. Initially, a starter dike is constructed of borrow materials (such as soil, gravel or sand) to contain the first few years of tailings production. Subsequent raises may be constructed of borrow material, rockfill or compacted tailings. As shown in Figures 1 to 3, there are three widely used construction methods of TSF raising:

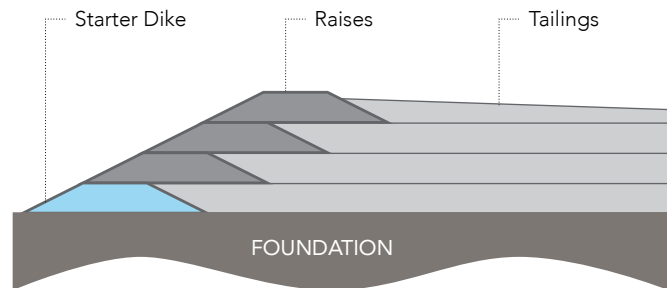
**Figure 3:** The **upstream method** involves constructing each raise in the upstream direction such that they are partially supported on the tailings deposited after the previous raise. It is the most economical method but may be more vulnerable to failure due to the reliance of the tailings as a foundation for the raises. Unless properly designed and constructed, the TSF may be more susceptible to failure due to failure of the tailings used as foundations, internal erosion or seismic activity.

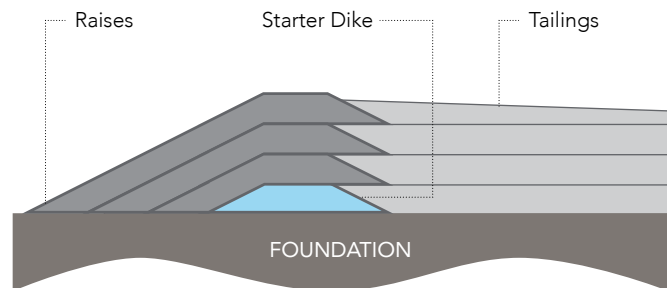
**Figure 4:** The **center-line method** is a combination between the upstream and downstream methods. The raises are essentially constructed on top of one another without significant reliance on the tailings and limited encroachment on the downstream terrain.

The three methods shown here (upstream, downstream and center-line) are basic concepts; in practice, there is a wide variety of geometries and techniques used in the design and construction of TSF.

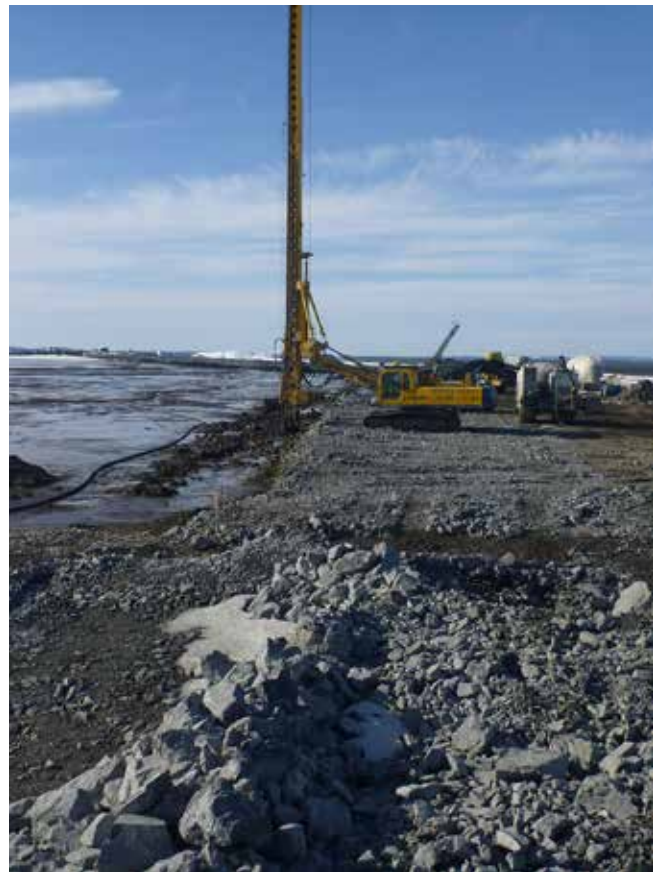
Deep Soil Mixing Technology  
Kittilä Mine

- As a partner of the Research Institute on Mines and Environment (RIME) UQAT- Polytechnique, Agnico Eagle supports and participates in research that addresses the management of TSFs. Through this research, a series of large-scale experimental cells have been constructed to test the long-term performance of final tailings pond covers for the LaRonde and Canadian Malartic mines.
- Some of the innovations resulting from this research have already been implemented at our sites, such as the use of waste rock inclusions at Canadian Malartic mine.
- Our Kittilä mine in Finland is utilizing foundation improvement technology (Deep Soil Mixing) to improve the tailings that will be used as a foundation for an upstream raise.

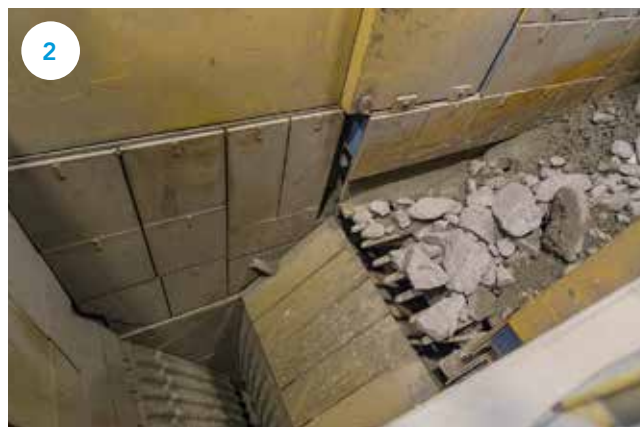
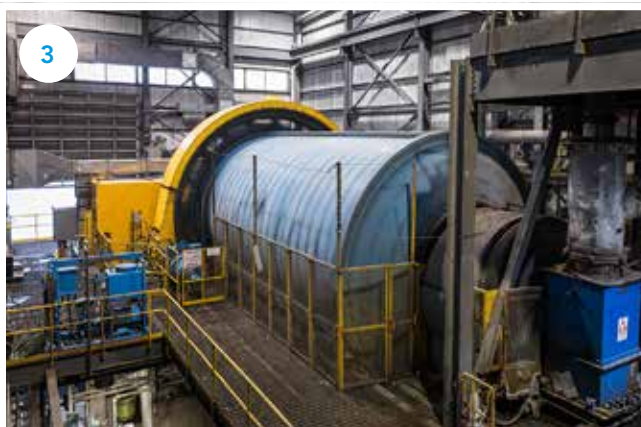
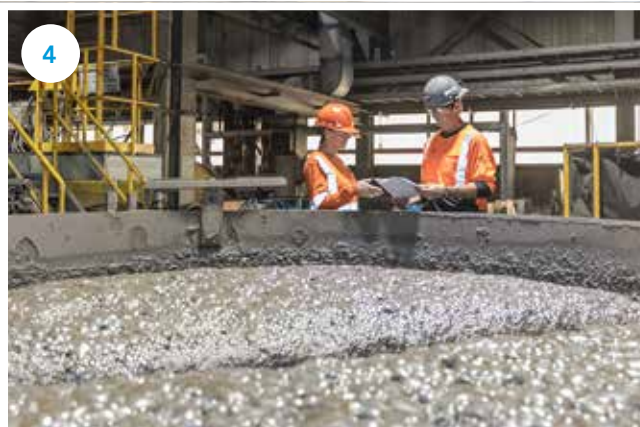
**Comminution (3)**, where the rock fragments are ground to fine particles (e.g. silt size) to allow the liberation of the valuable metals and minerals (e.g. gold); and

**Metals and Mineral processing (4)**, where the valuable mineral (e.g. gold) is separated and concentrated by either mechanical means (e.g. gravity circuit) or chemical means (e.g. flotation or cyanidation). Somewhere in the process, water is added to the fine particles of rock to facilitate mineral processing and transport as a slurry.
